CONDITIONAL USE – COMMERCIAL ENERGY FACILITY

Application for a commercial photovoltaic solar power generation facility.
Please see accompanying attachment, Exhibit A: Main Proposal

In support of Moffatt Road Solar Farm LLC Conditional Use Permit Application

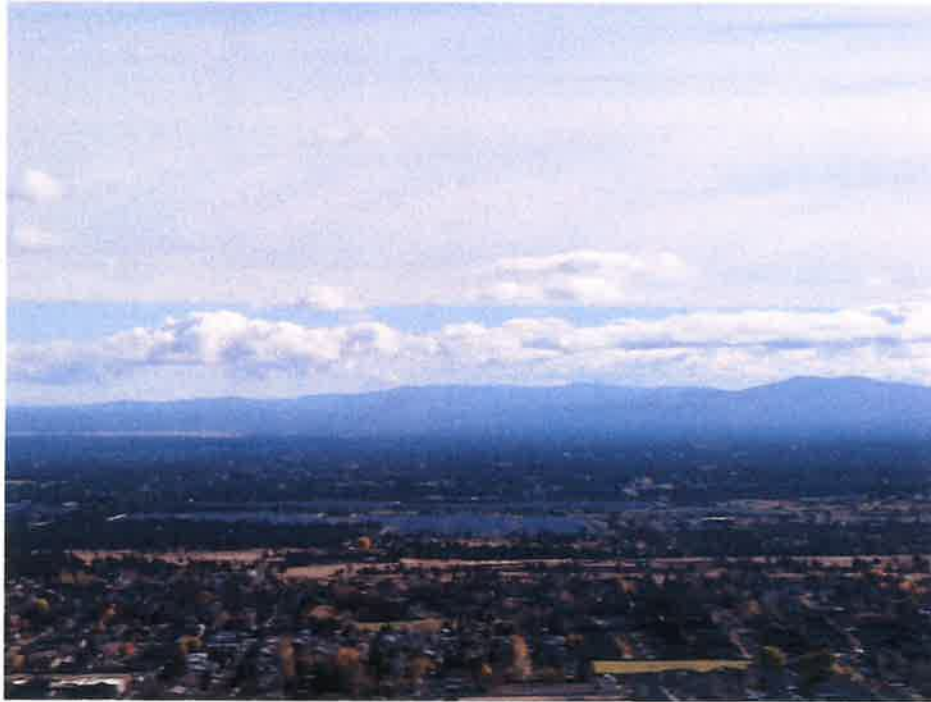
Image A-2 - PV Facility in central OR

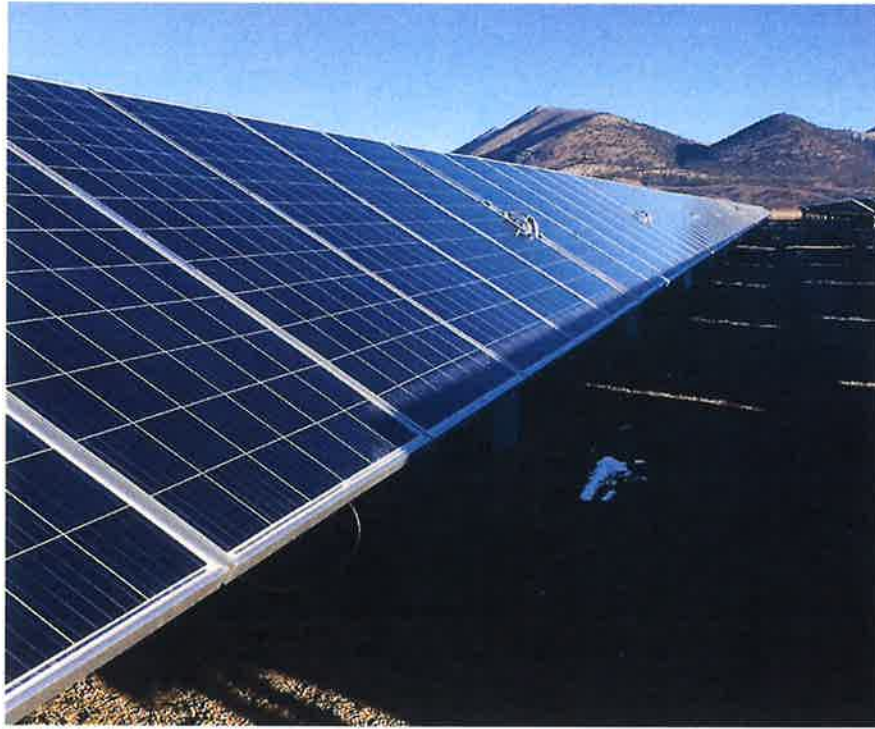
Racking structures for PV modules may be either “fixed tilt” (stationary) or “single axis tracking”. They are generally steel, ground-mounted structures less than 15’ tall, located up to 25’ apart. Final racking, modules, inverters, and other equipment selection will be subject to final design considerations before construction (and may be updated from time to time over the life of the Facility) based on commercially available products and other related commercial considerations. Spacing of rows and blocks of rows on the property will be interdependent with and subject to the acreage limitations and proposed shared use with continued agricultural use proposed herein. Sometimes modules are landscape or portrait mounted on racks; sometimes there are multiple rows of panels on the racking structures. Sometimes different racking structures may be used for different parts of a site due to design limitations, civil and geotechnical concerns, configurational issues, or other concerns.

Figure A-3 – PV Module Array strings on single axis tracking racking (central OR)

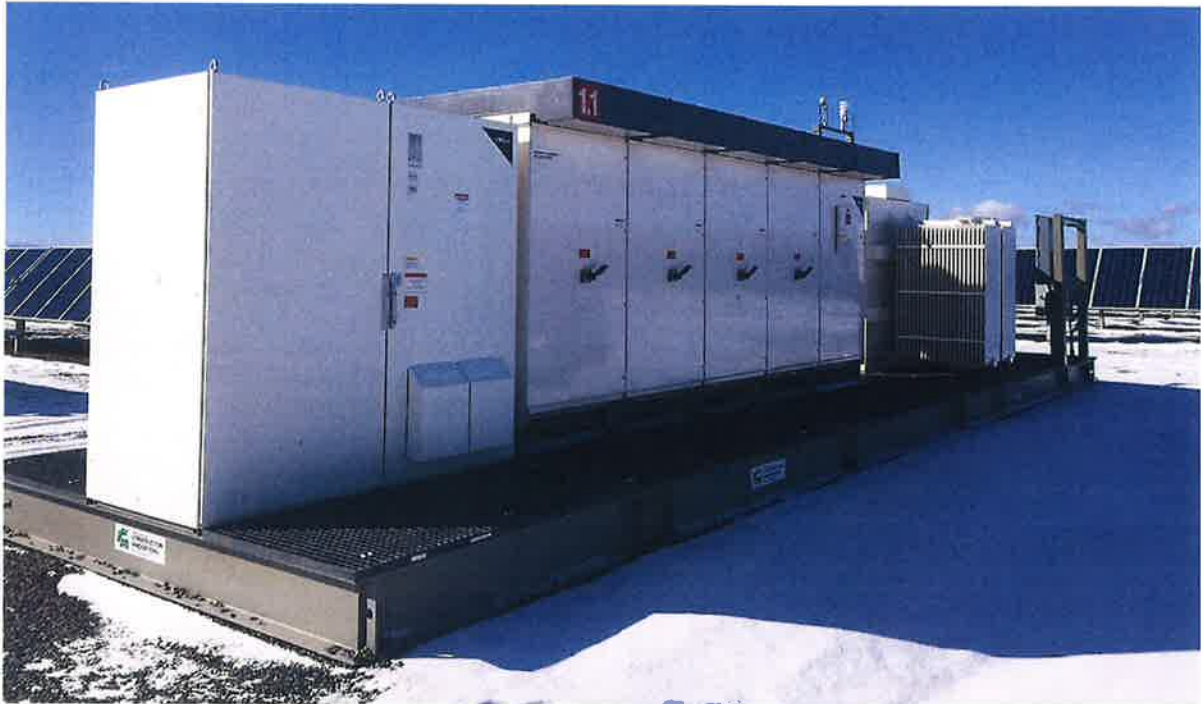
Figure A-4 Power Collection Station example in central Oregon.

Factory pre-built power collection stations may be installed throughout the site and are typically mounted on steel foundation supports similar to site module racking and tracker systems. Power collection stations are usually comprised of an inverter made by a qualified solar inverter OEM such as SMA or Power Electronics, a step up transformer, typically 1000 or 1500V:34.5kV. Inverters typically include their own DC combiner cable inputs. Stations also include AC breaker cabinets, local house power transformer and distribution, and specialized equipment for tracker controls, network communications, and meteorological equipment. See Figure A-5 showing a typical station.

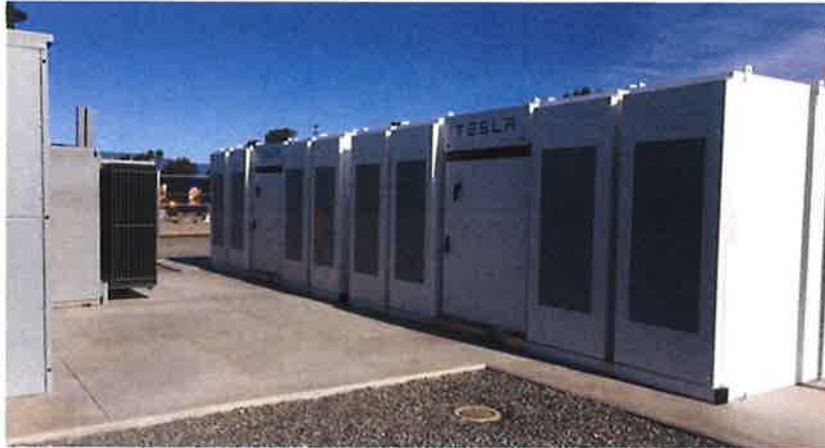
Figure A-5. Example inside substation, showing modular energy storage equipment, 34.5 kV transformers, breaker cabinets, and ancillary equipment on concrete mounted pads.

Substation equipment consists of a multi-element protection and relay system for 34.5 kV feeders, main power transformer, and breaker relays, metering, and plant control and monitoring systems. It may also house the energy storage feeder and system equipment,

examples of which are shown in Figure A-5 below (which might also be located elsewhere in the Site).

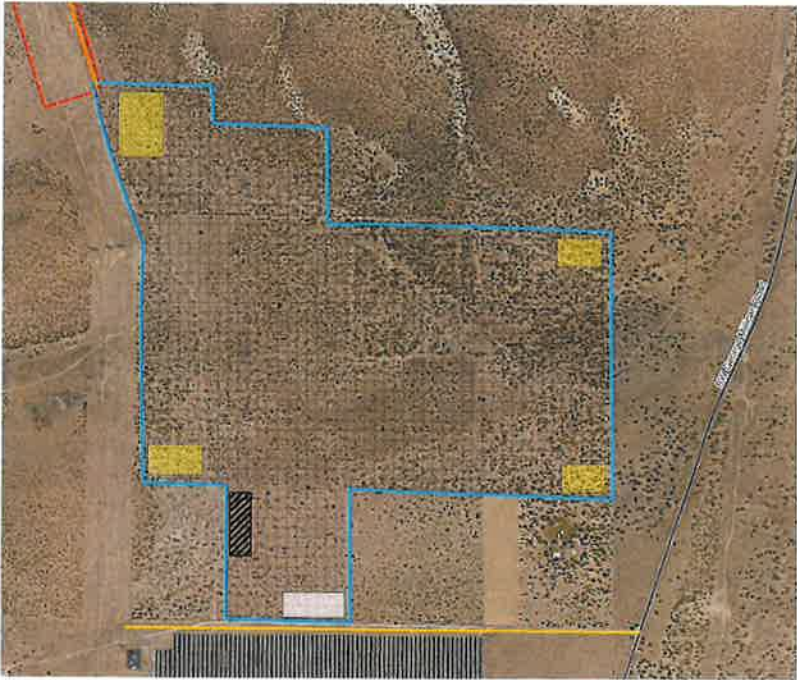
Notes: Preliminary. Not for Construction	Prepared for: Moffatt Road Solar Farm LLC	TITLE: SITE PLAN OVERALL	
		DRAWN BY: PLB	
		REV: NA	PAGE: PE of 3

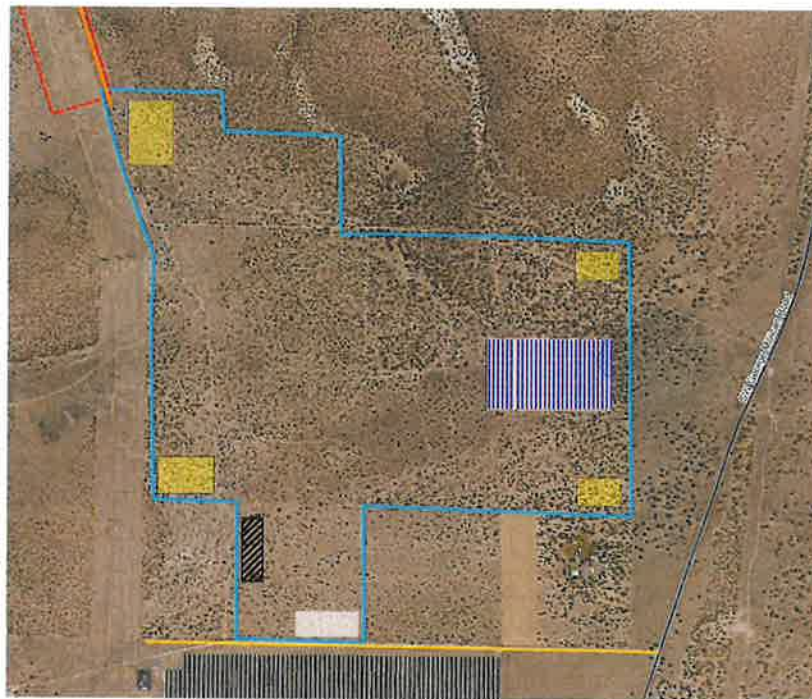
Notes: Preliminary, Not for Construction	Prepared for: Moffatt Road Solar Farm LLC	TITLE: SITE PLAN: PV LAYOUT EXAMPLE
		DRAWN BY: PLS
		REV: N/A PAGE: P3 of 3

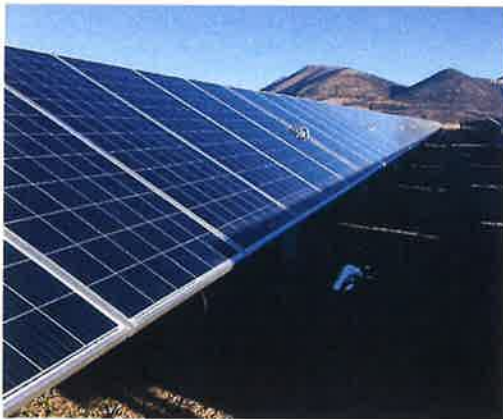
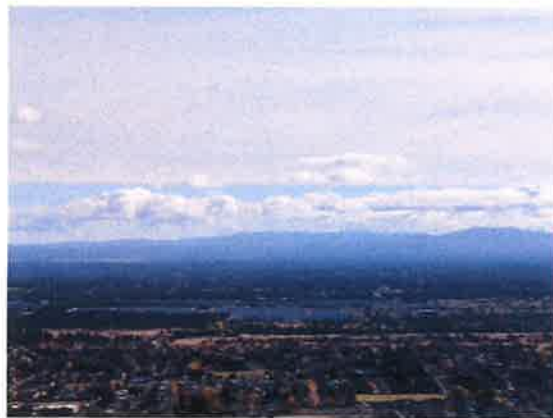
Figure [D-1] Views of a single PV tracker row, and PV facility from above in distance.

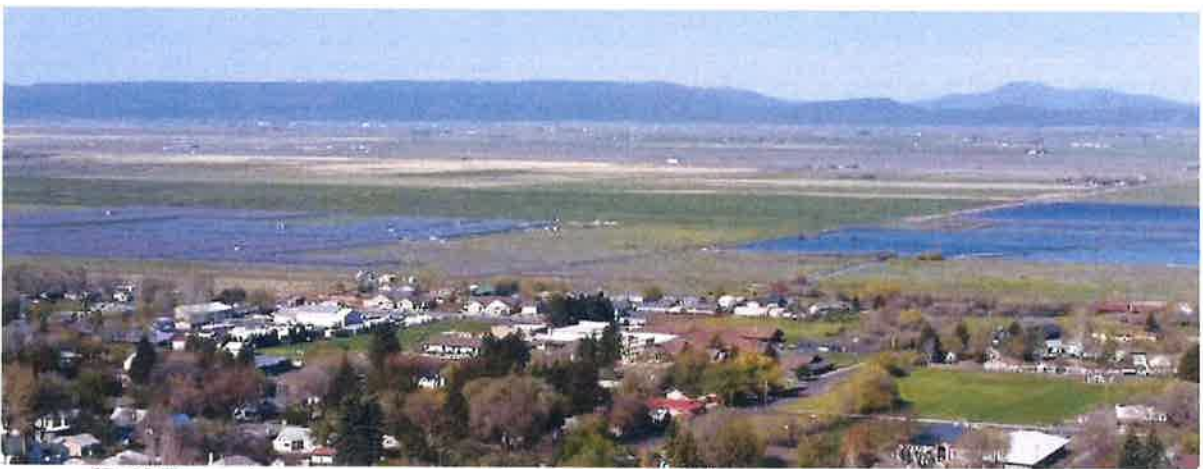
Figure [D-2] Example image of tracking solar PV installation, aerial angle view.

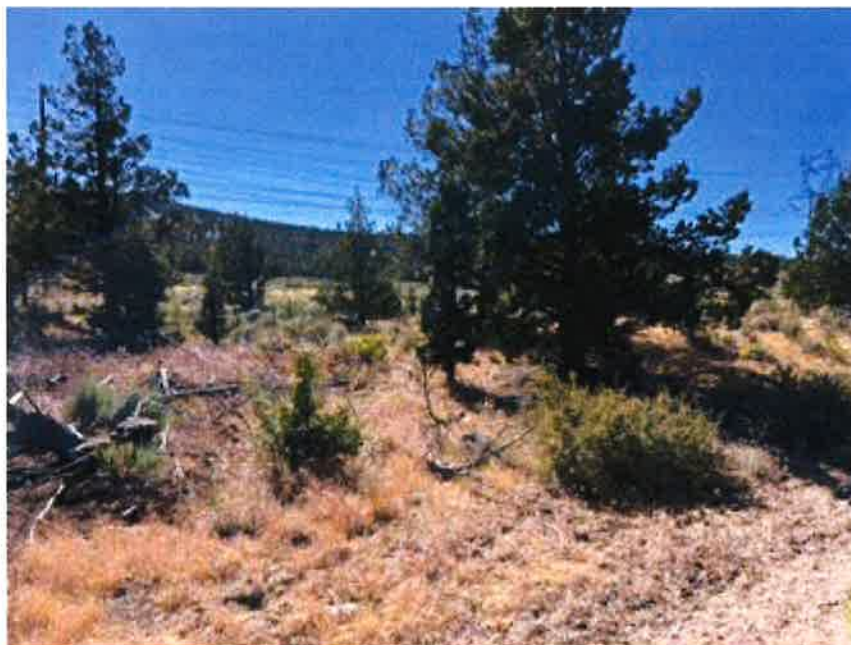
Photo 15. North portion of Ephemeral Stream 1 facing southeast. Photo taken June 24, 2024.

Photo 15. North portion of Ephemeral Stream 1 facing southeast. Photo taken June 24, 2024.

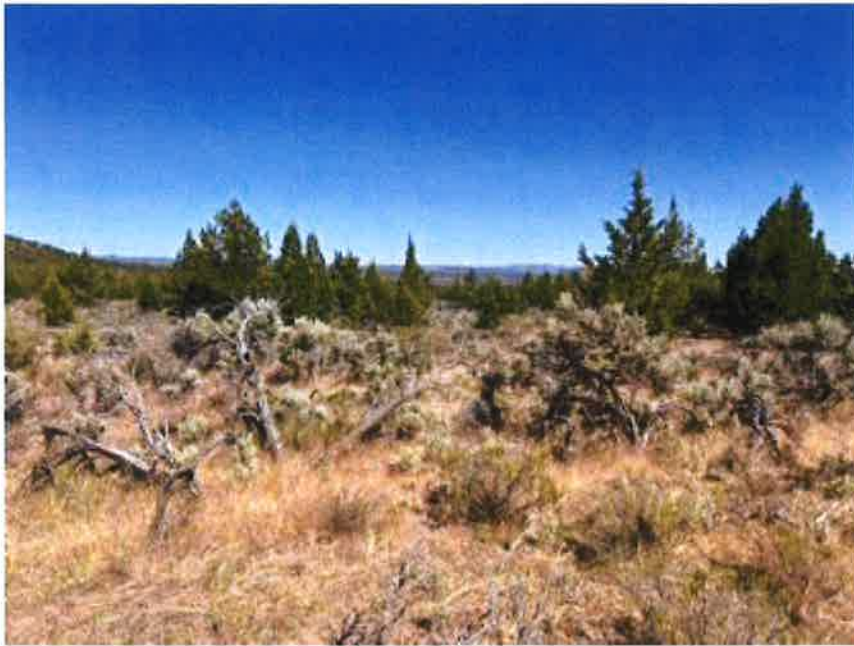
Photo 16. Location of NWI polygon facing west. NWI polygon was not found. Photo taken June 24, 2024.

Photo 16. Location of NWI polygon facing west. NWI polygon was not found. Photo taken June 24, 2024.

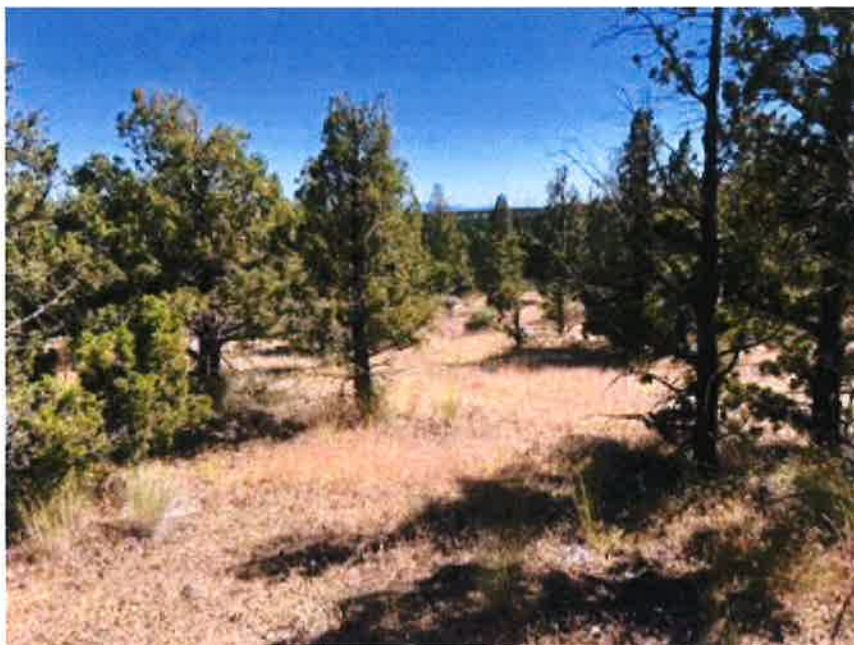
Photo 17. Location of NWI polygon facing southeast. NWI polygon was not found. Photo taken June 24, 2024.

Photo 17. Location of NWI polygon facing southeast. NWI polygon was not found. Photo taken June 24, 2024.

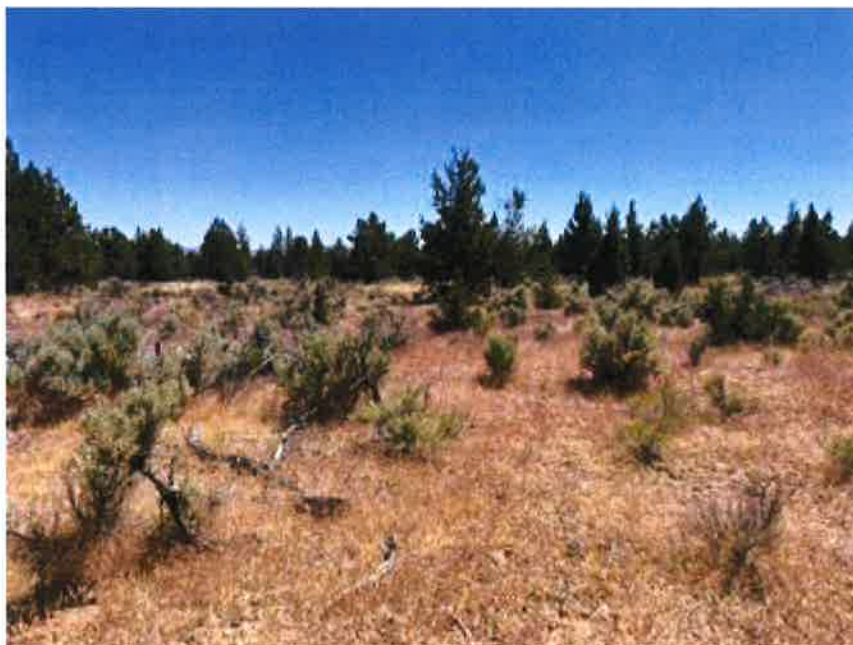
Photo 19. West portion of Ephemeral Stream 2 facing east. Photo taken June 24, 2024.

Photo 19. West portion of Ephemeral Stream 2 facing east. Photo taken June 24, 2024.

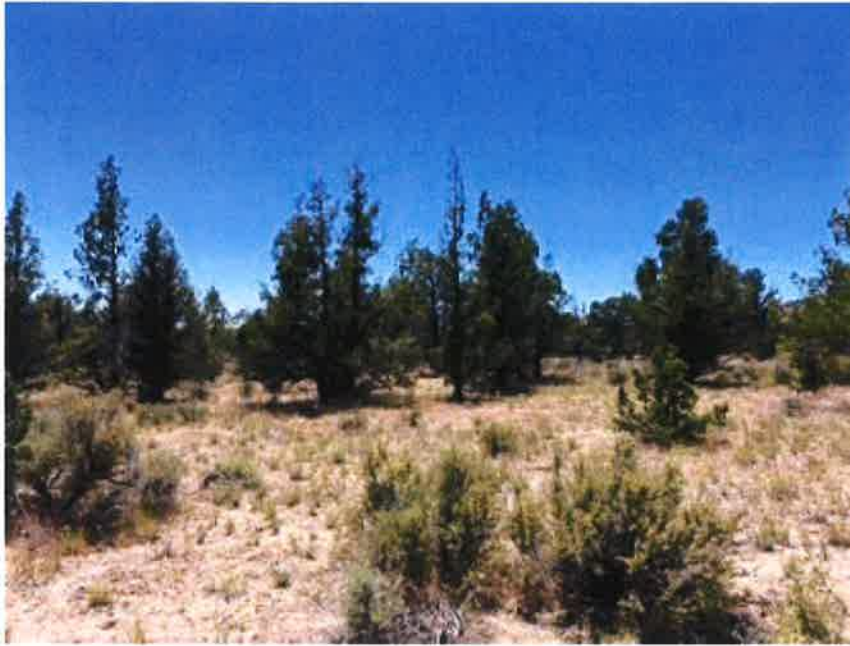
Photo 22. South portion of Ephemeral Stream 3 facing southeast. Photo taken June 24, 2024.

Photo 22. South portion of Ephemeral Stream 3 facing southeast. Photo taken June 24, 2024.

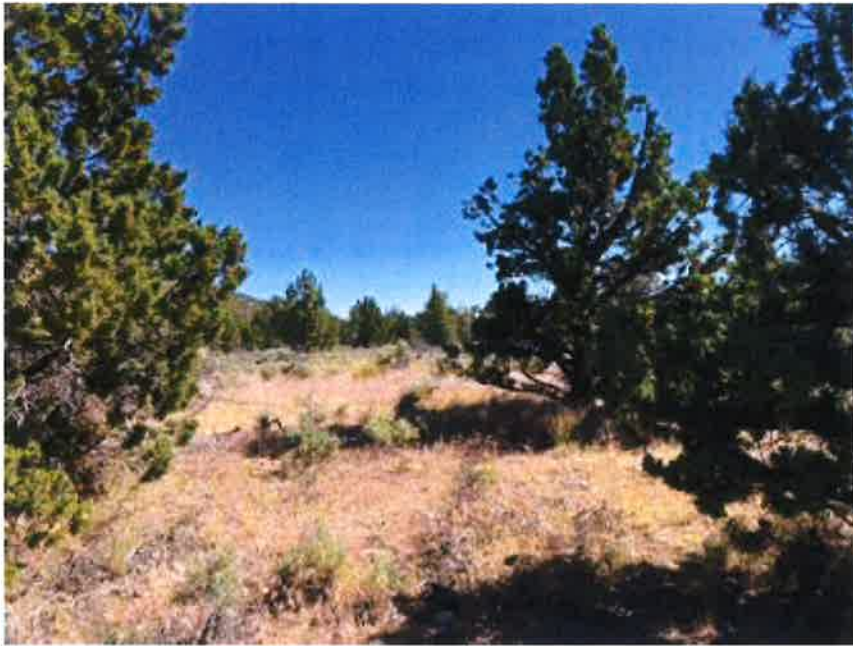
Photo 24. Location of NWI polygon facing southwest. NWI polygon was not found in this area. Photo taken June 24, 2024.

Photo 24. Location of NWI polygon facing southwest. NWI polygon was not found in this area. Photo taken June 24, 2024.

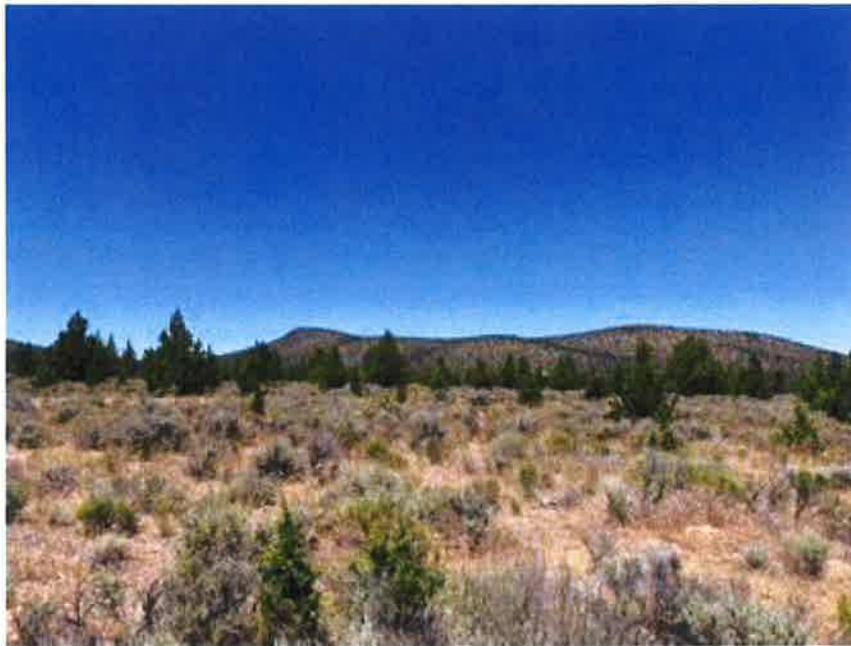
Photo 30. West part of Ephemeral Stream 5 looking east. Photo taken June 24, 2024.

Photo 30. West part of Ephemeral Stream 5 looking east. Photo taken June 24, 2024.

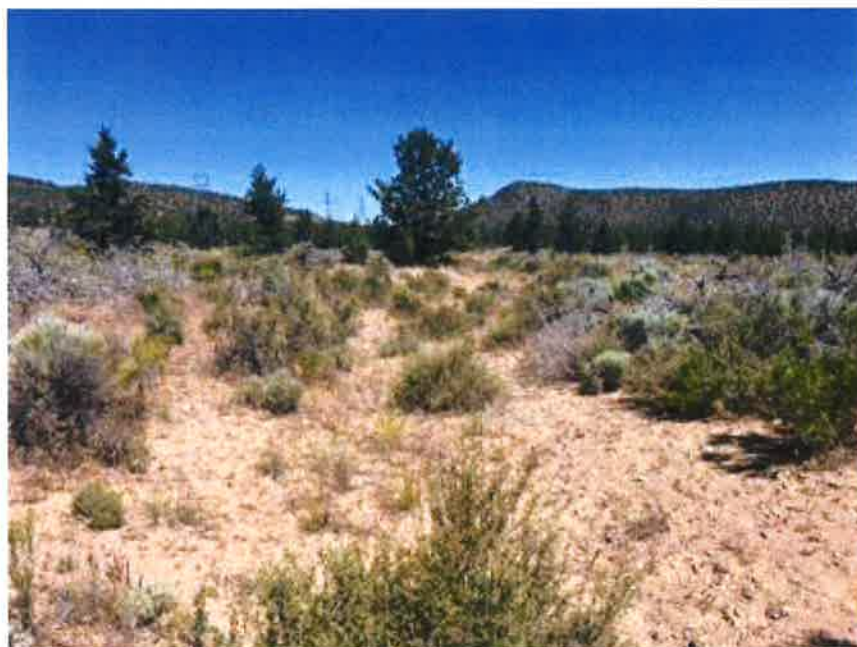
Photo 33. South part of Ephemeral Stream 6 looking north downstream. Photo taken June 24, 2024.

Photo 33. South part of Ephemeral Stream 6 looking north downstream. Photo taken June 24, 2024.

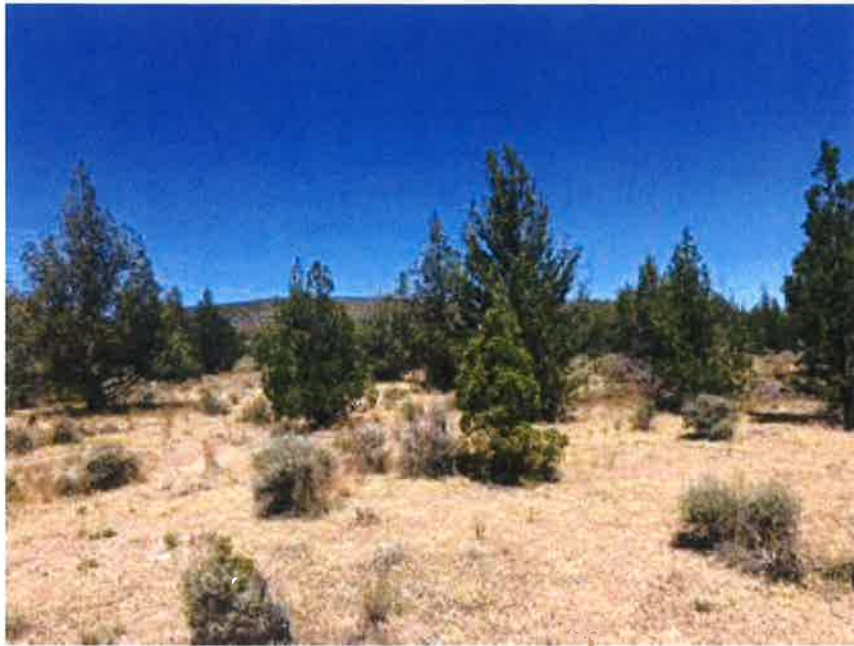
Photo 34. North part of Ephemeral Stream 6 facing northwest. Photo taken June 24, 2024.

Photo 34. North part of Ephemeral Stream 6 facing northwest. Photo taken June 24, 2024.

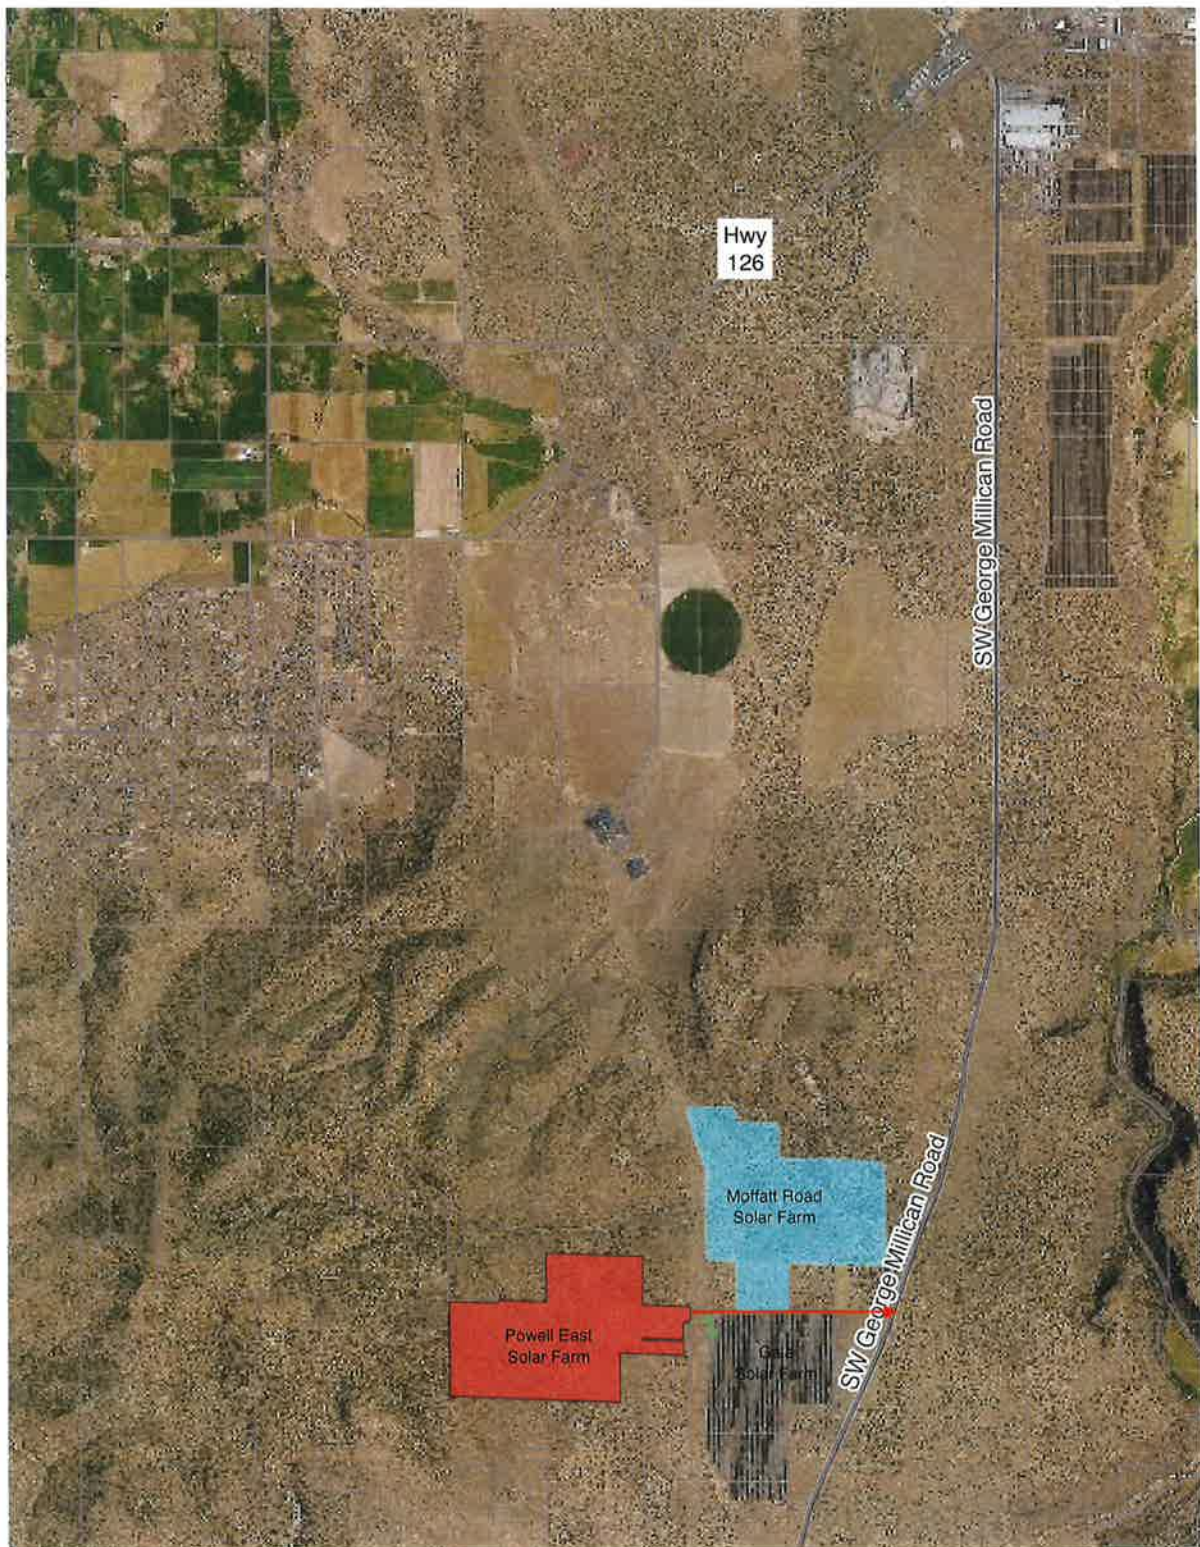
Figure 1. Site Vicinity Map. *Image Source: Crook County GIS.*

This letter provides an assessment of the transportation impacts anticipated with the proposed solar farm located within a 378-acre parcel on the west side of George Millican Road, immediately north of the existing Gala Solar Farm. Vehicular access to the site is provided from the site to SW George Millican Road through an existing access road within an 80' wide strip along the northern border of the existing Gala Solar Farm, which will provide shared access to the Powell East Solar, Gala Solar, and the proposed Moffatt Road solar site. The overall tax lot (tax lot 1615000000300) is a 2,438.63-acre site zoned for Exclusive Farm Use, which per CCC 18.24.025 allows commercial photovoltaic energy systems to the extent permitted by State law. Within the overall parcel approximately 320 acres will be used for the solar facility. Figure 1 illustrates the overall location of the tax lot, the approximate solar facility boundaries of the site and previously approved locations that surround it, and the location of the proposed (shared) access route onto Millican Road.

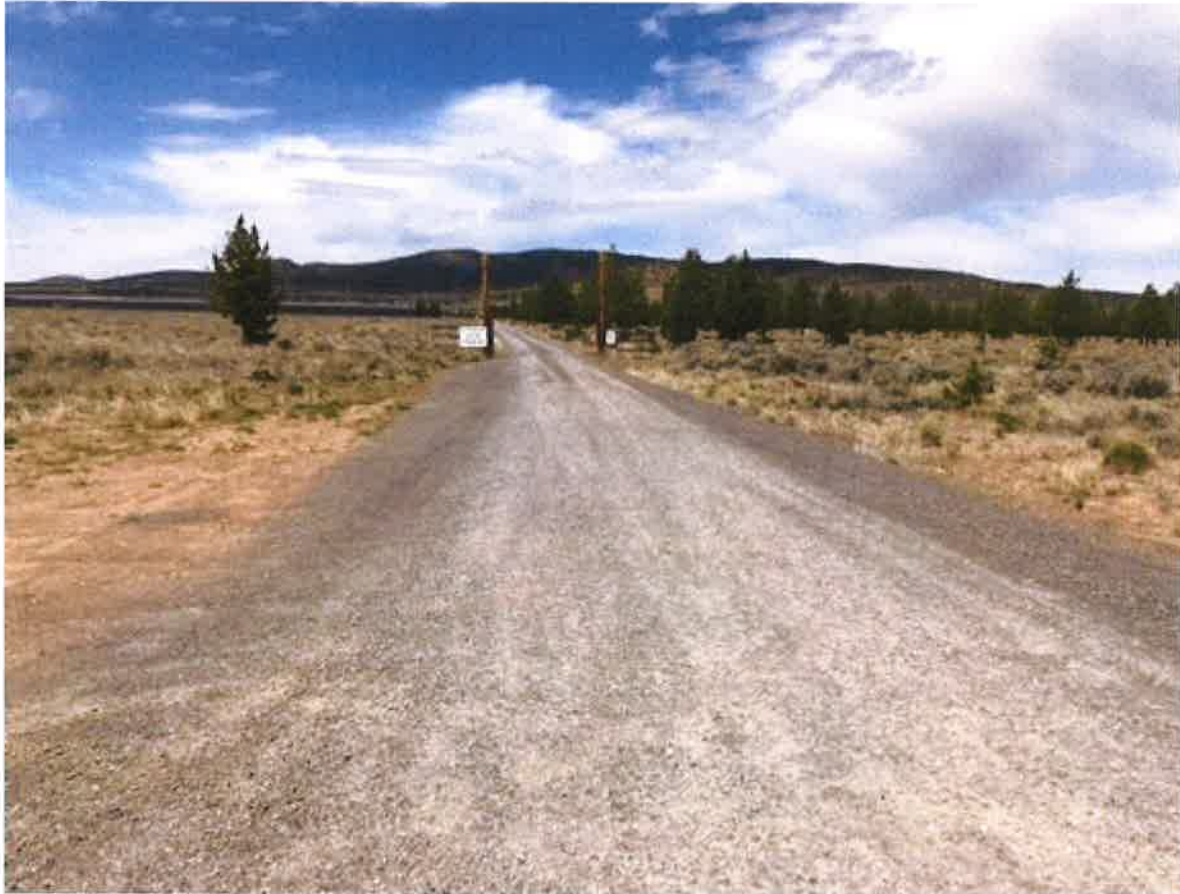
The shared access to the property is proposed from a private driveway connection onto George Millican Road, which is located along a straight, flat tangent segment of the facility. There is currently an existing gated access near this location that serves as a shared access with the Powell East and Gala solar farm, as shown in Figure 3. It was noted that the location of the access is along a portion of Millican Road that permits passing maneuvers today with a dashed centerline stripe.

Figure 3. Shared gravel access drive into the solar farms.

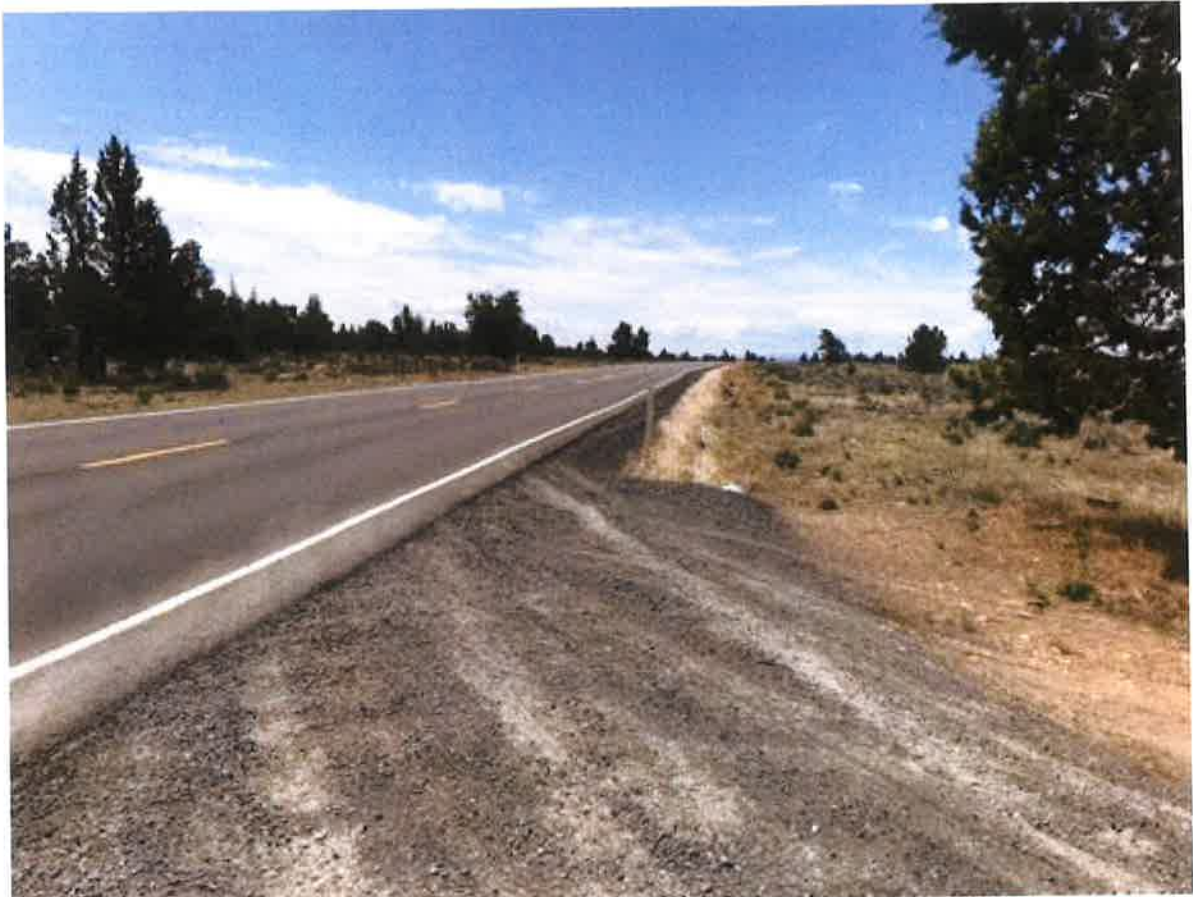
Prior field review was conducted along Millican Road as part of the prior solar application, with this review showing that these sight lines can easily be met with the current road grades and characteristics of the existing frontage. Figures 5 and 6 illustrate the current sight lines in this area.

Figure 5. Shared access location onto Millican Road facing south, highlighting the clear sight lines.

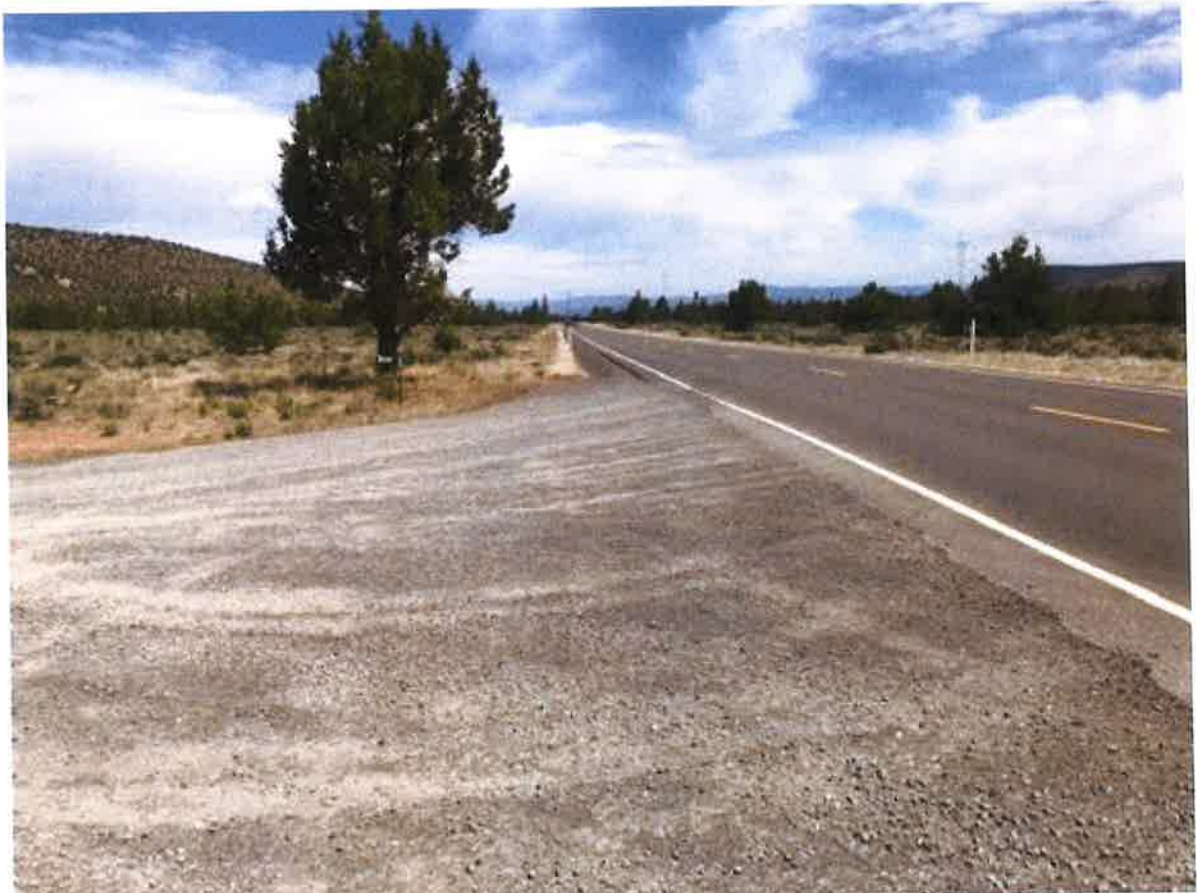
Figure 6. Shared access location onto Millican Road facing north, highlighting the clear sight lines.
