**Crook County Community Development  
Planning Division**  
300 NE 3<sup>rd</sup> Street, Room 12, Prineville Oregon 97754  
541-447-3211  
[plan@co.crook.or.us](mailto:plan@co.crook.or.us)  
[www.co.crook.or.us](http://www.co.crook.or.us)

**Conditional Use Application**  
**Mining and Aggregate**

**KNIFE RIVER – NORTHWEST  
APPLICANT’S BURDEN OF PROOF DOCUMENT  
CONDITIONAL USE PERMIT – AGGREGATE MINING**

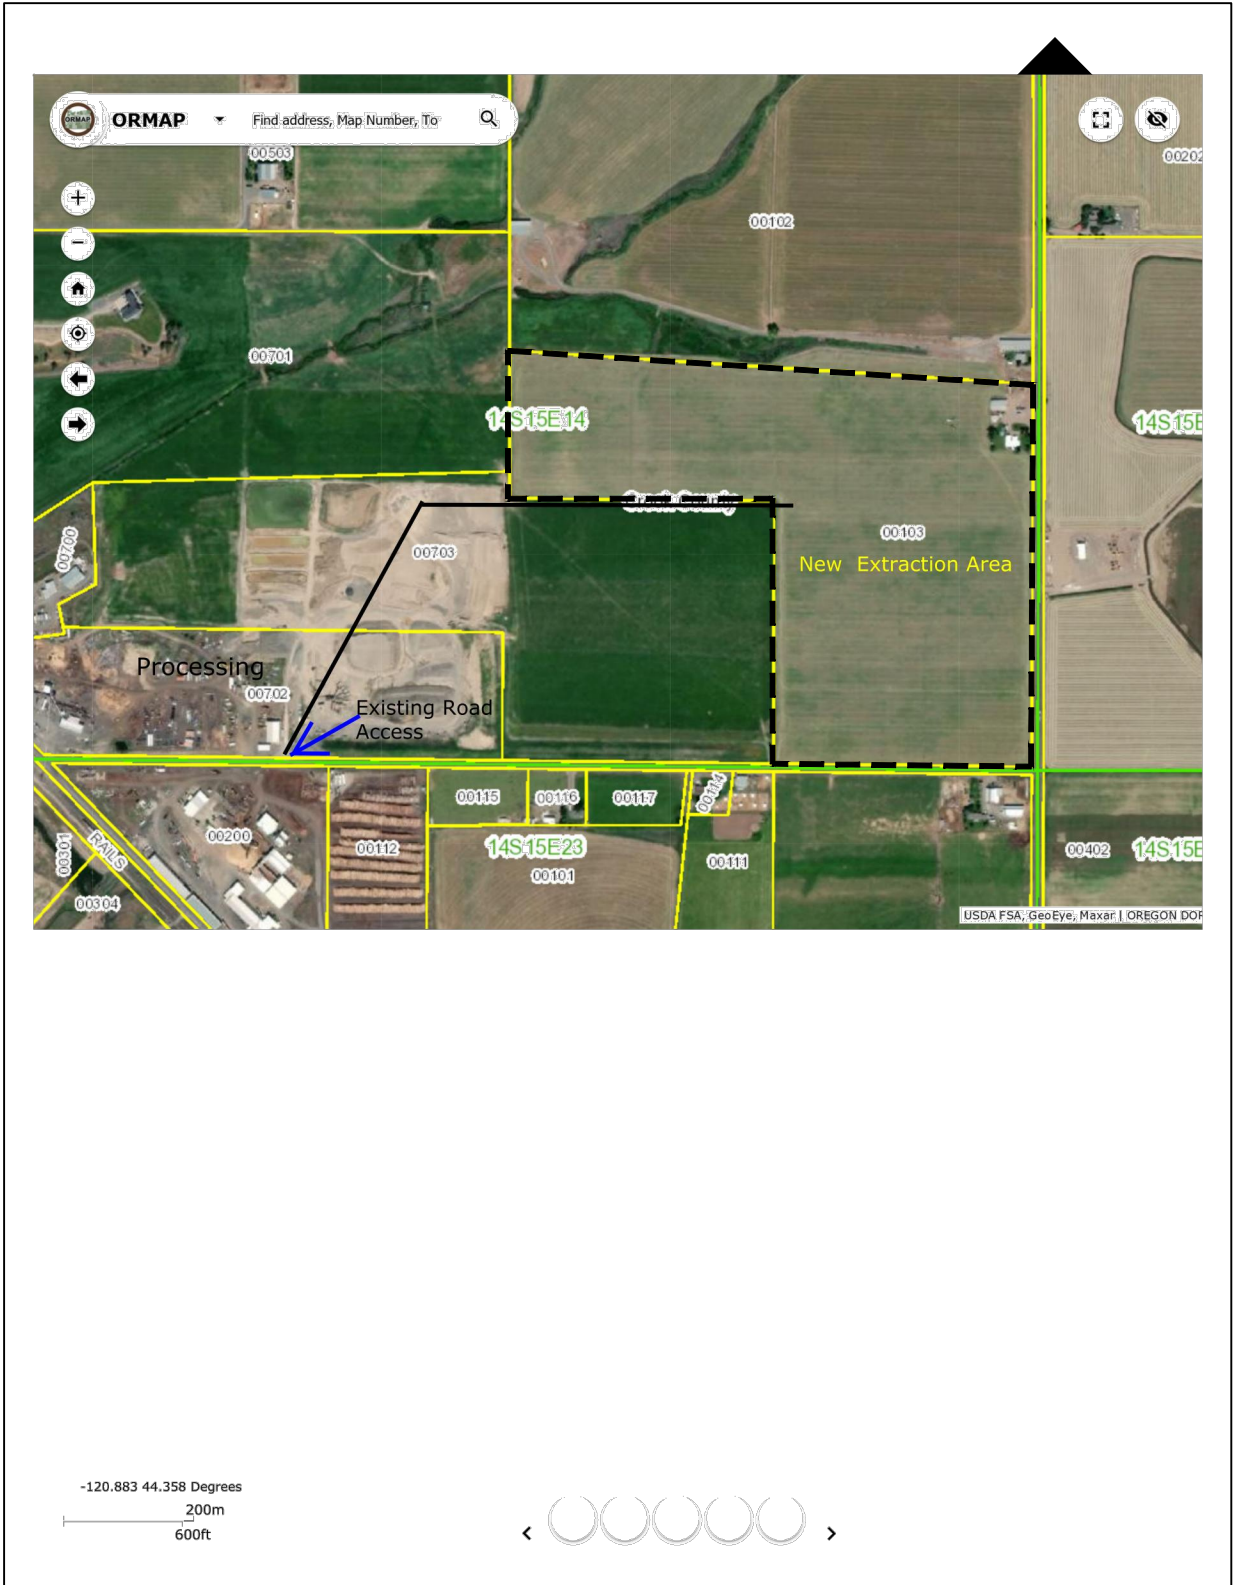
# Figure 2

## Woodward Aggregate Site Expansion Traffic Impact Study New Extraction Area

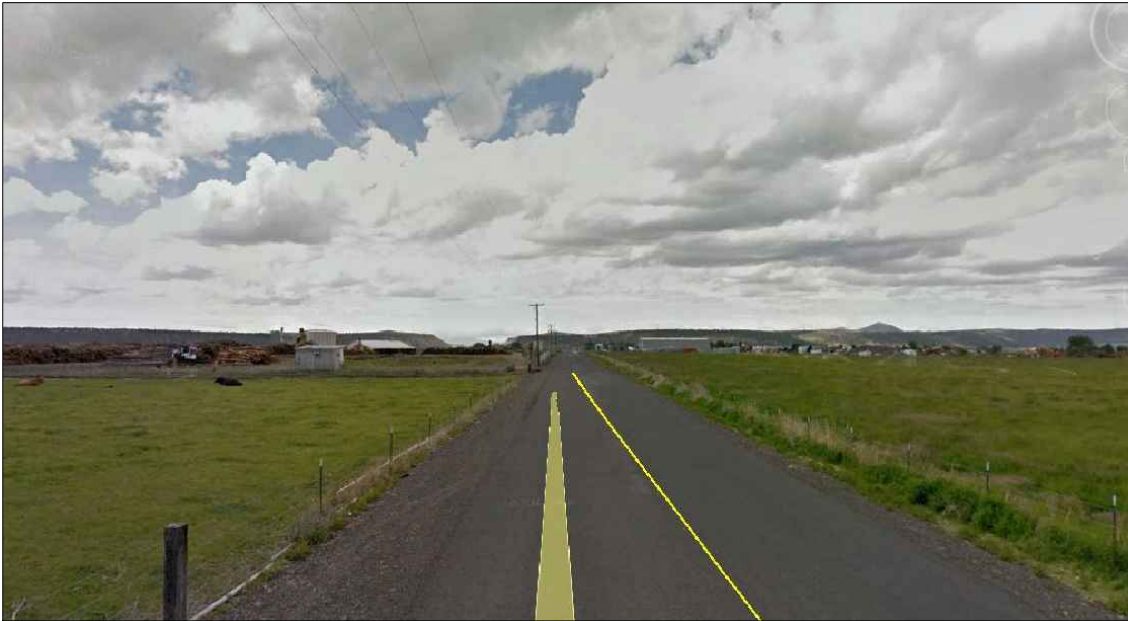
Photo 1 1000 Feet East of Driveway Looking West

Figure 2  
Woodward Aggregate Site Assessment  
Sight Distance Photos

Sight distance for the access driveway approach to Stahancyk Lane is excellent in both directions. Most trucks will be entering and exiting the site from the west, however local deliveries may enter and exit to the east. Figures 2 and 3, attached, show no obstructions to sight distance east or west of the access intersection. On Figure 2, Photo 1 is taken from 1000 feet east of the access looking west and Photo 2 is taken from the access looking east. The photos show that there is more than 1000 feet of sight distance. On Figure 3, Photo 3 is taken from 1100 feet west of the access looking east and Photo 4 is taken from the access looking west. The photos show that there is more than 1100 feet of sight distance. The photos are from Google Earth street view dated June 2012. We know of no changes on the road since that time that would affect sight distance. Figure 4 attached, shows the access driveway location and the locations of the photos on Stahancyk Lane.

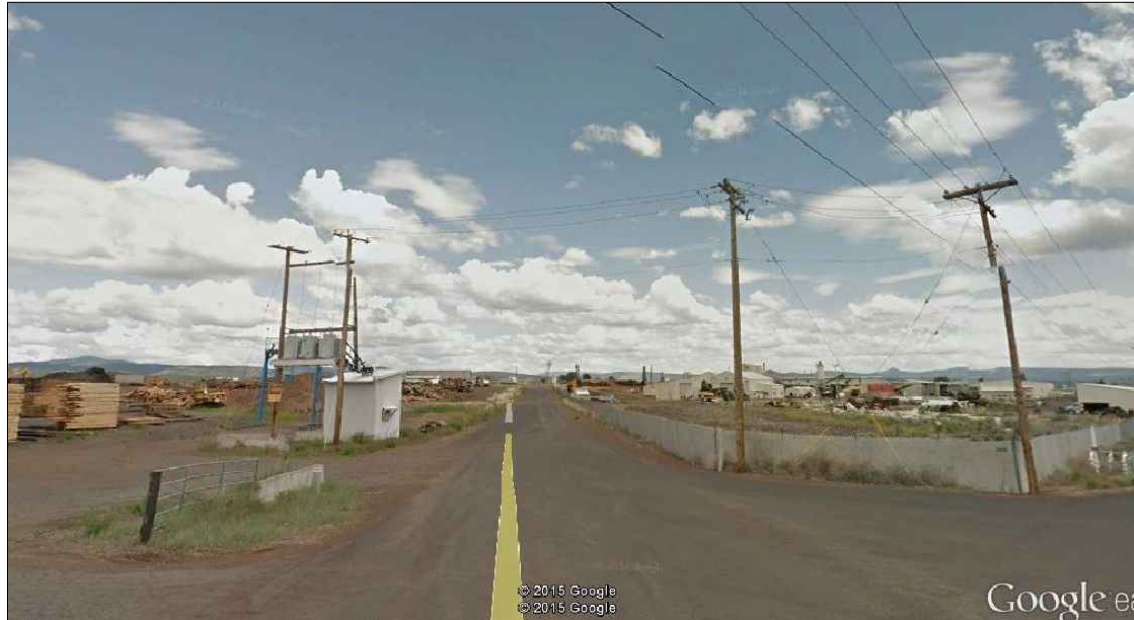
Photo 3 1000 Feet West of Driveway Looking East

### Sight Distance Photos

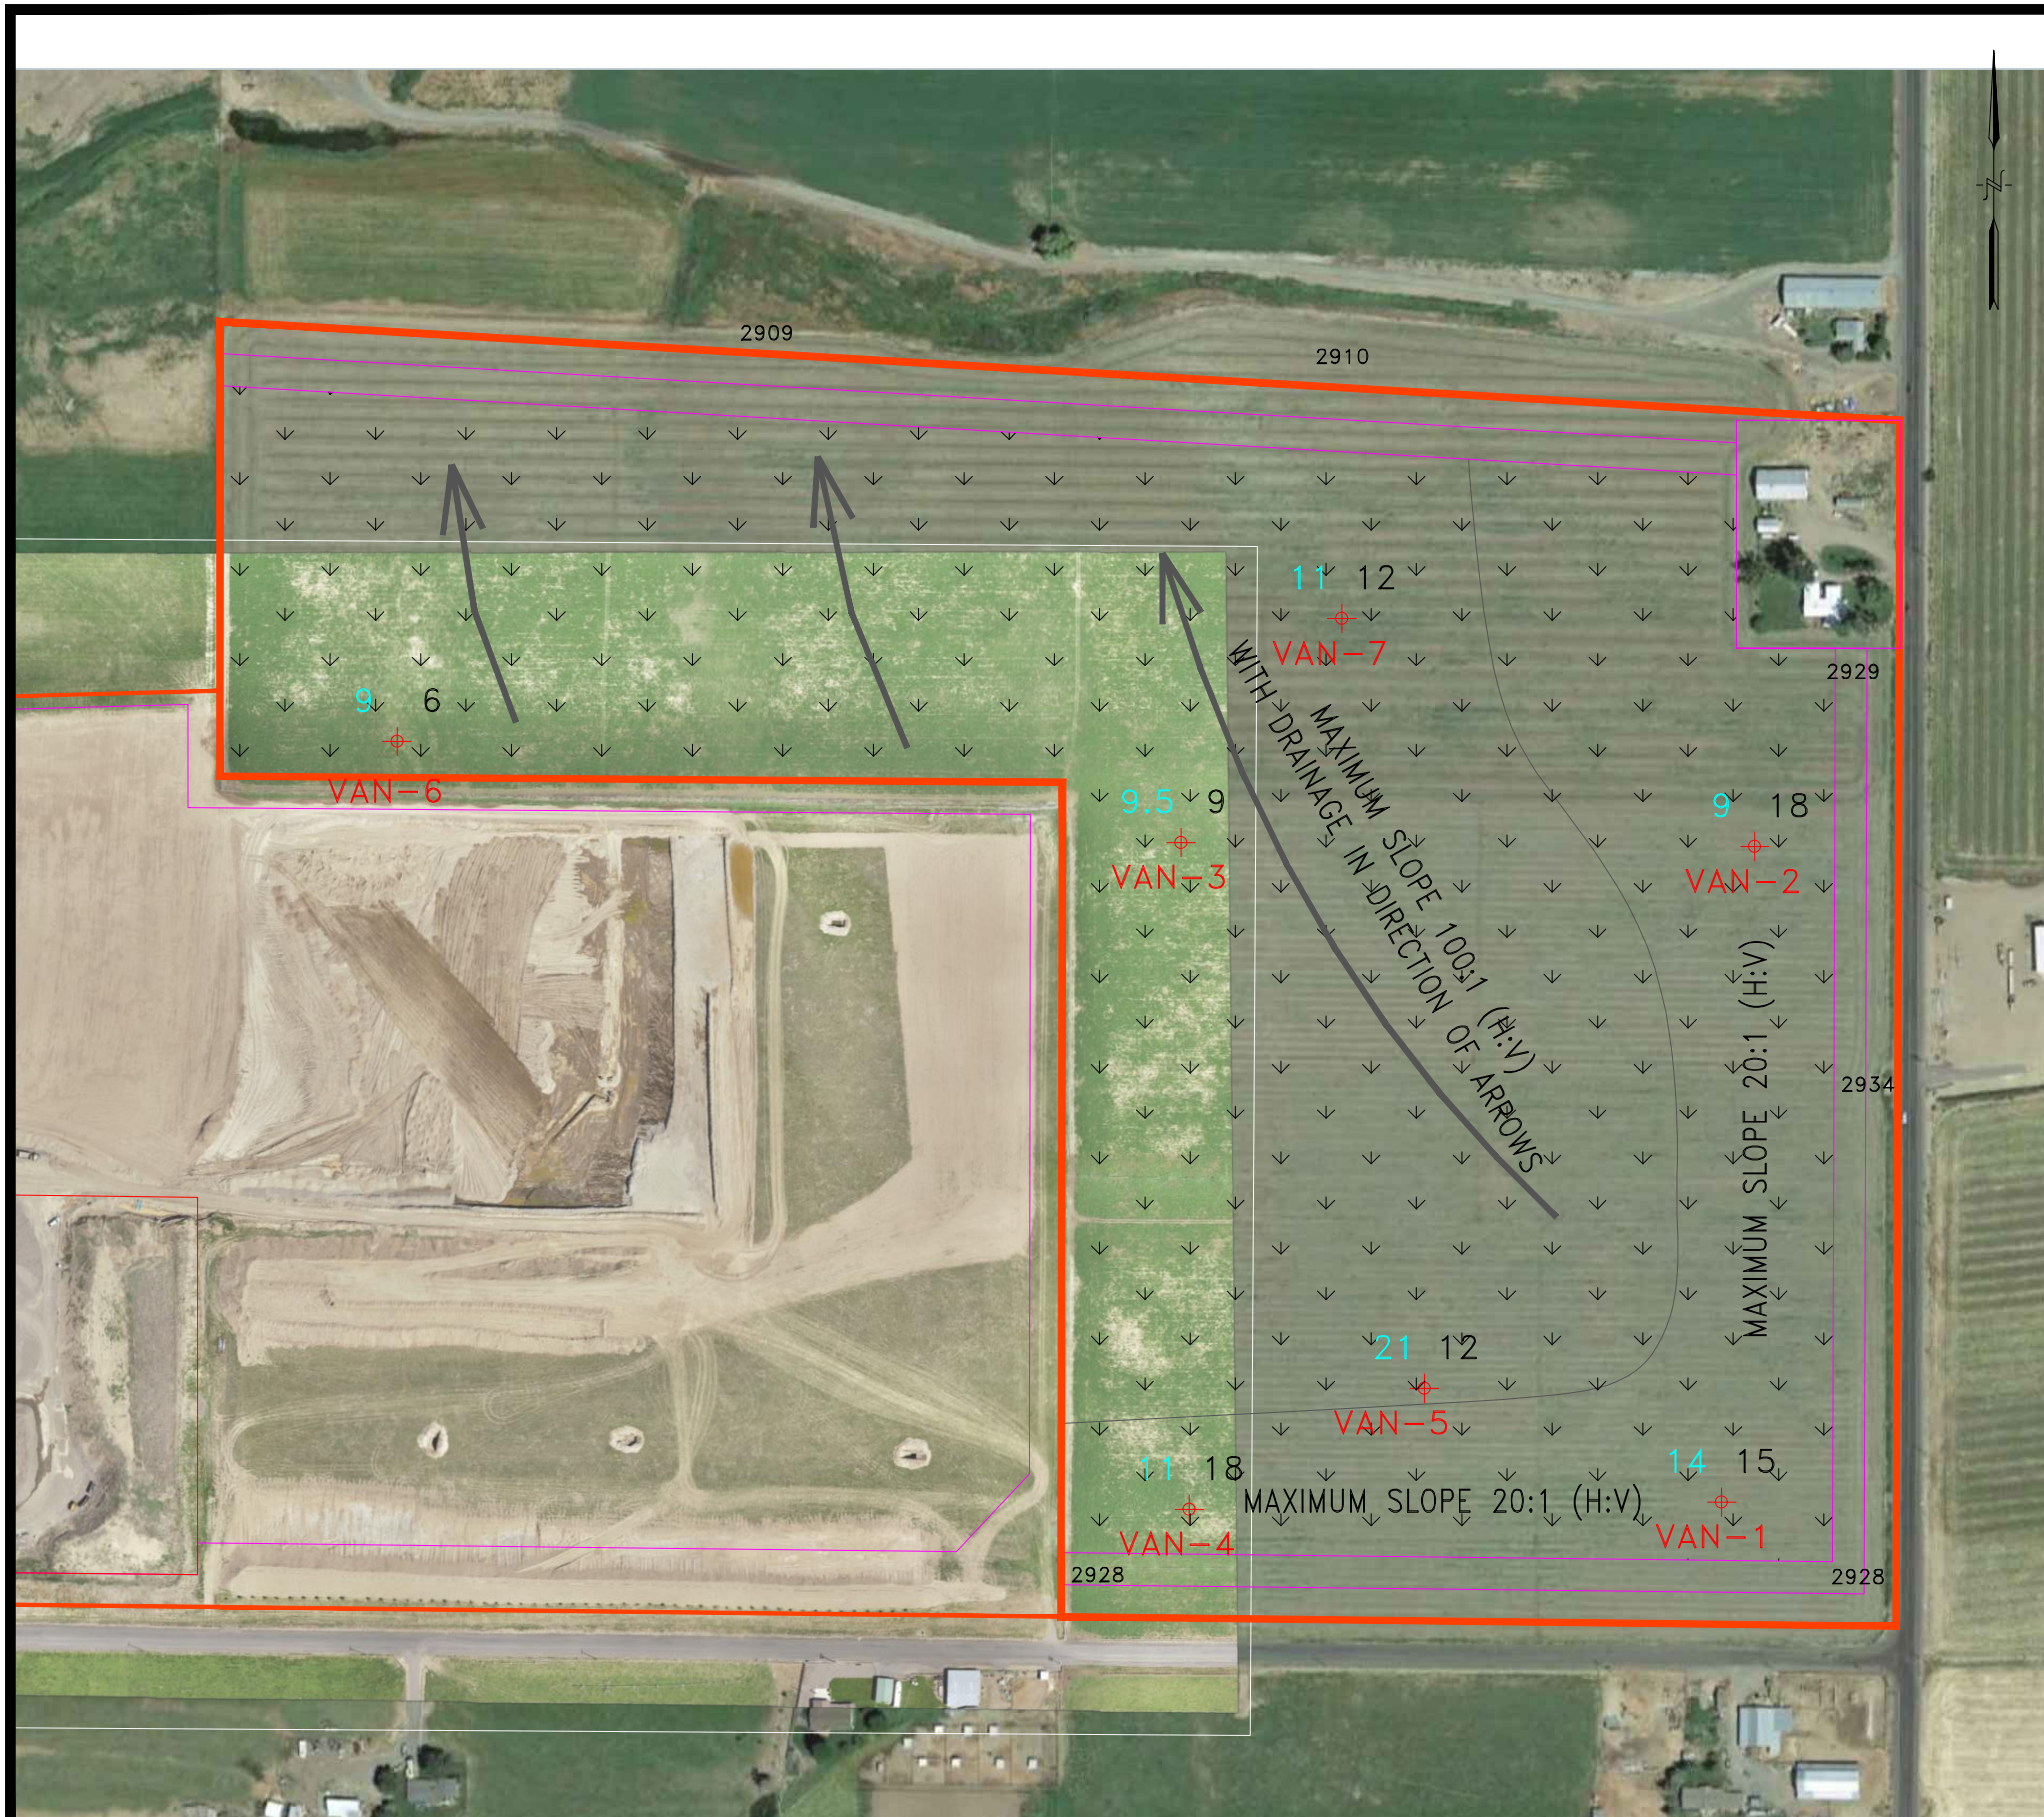
- 14 - POSSIBLE AGGREGATE THICKNESS (FT) - Blue
- 15 - OVERBURDEN THICKNESS (FT) - Black
- VAN-X BORING NUMBER - RED
- POSSIBLE MINING AREA
- APPROXIMATE PROPERTY BOUNDARY
